A Precise Home Inspection

Client Name: Sample Report

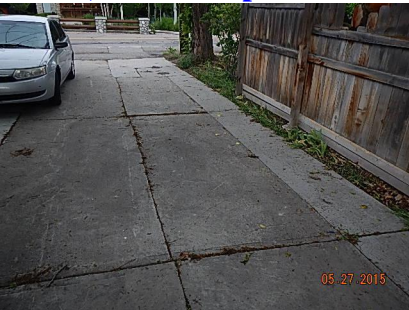
Step #	Component	Comment
01.	Driveway	<p>Repairs Recommended. Material:+Concrete. Surface raised or settled, creates trip hazard.</p>

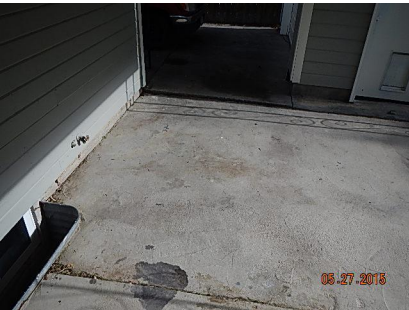
02.	Sidewalks	Appears Serviceable. Materials:+Concrete.
03.	Retaining Walls	N/A.
04.	Patio	<p>Safety Hazard. Material:+Concrete. Drainage is directed toward the property which may allow water intrusion or foundation settling. The patio surface was raised or settled creating a trip hazard.</p>

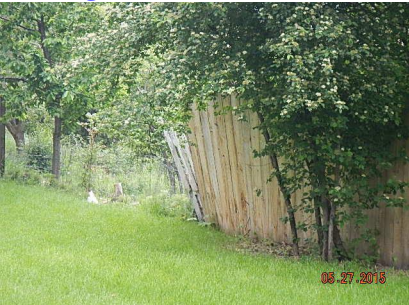
05.	Patio Cover	N/A.
06.	Decks/Porch	N/A.
07.	Fences & Gates	<p>Repairs Recommended. Material:+Wood, Chainlink. Damaged fencing present. Gates need adjustment or repair. The fencing had broken/missing boards and posts at the time of the inspection, leaning noticed.</p>

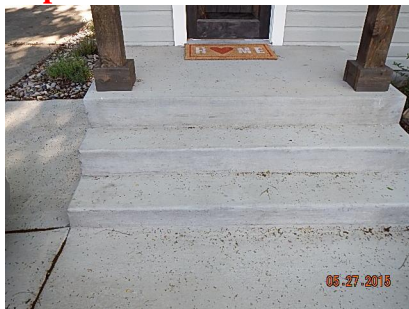
08. Exterior Stairs **Safety Hazard. The rise between steps is inconsistent, making the steps difficult to use and unsafe.**

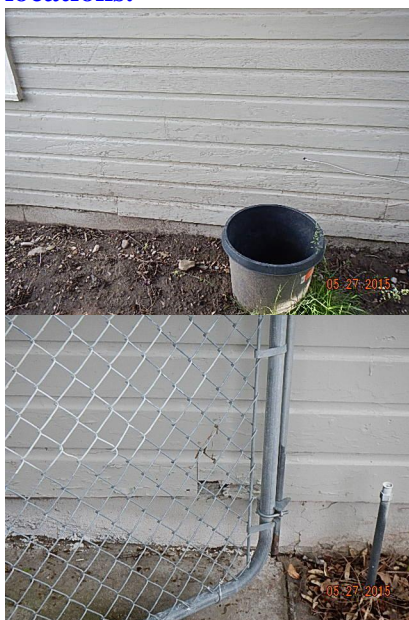
09. Exterior Walls **Repairs Recommended. Structure:+Wood Frame: Wall Covering:+Wood Siding, brick. Damaged siding at: numerous locations.**

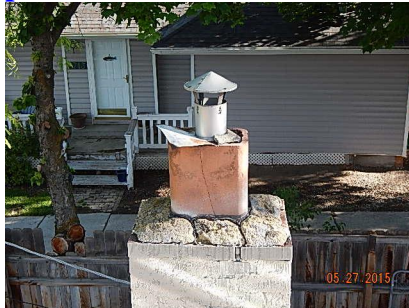
11. Chimney(s) **Repairs Recommended. Material:+Brick. Damaged chimney cap present.**

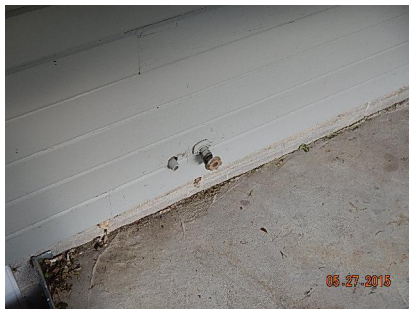
13. Hose Faucets **Repairs Recommended. Frost Type:+Yes: Anti-siphon valves:+Yes. The rear hose faucets were inoperative at the time of inspection.**

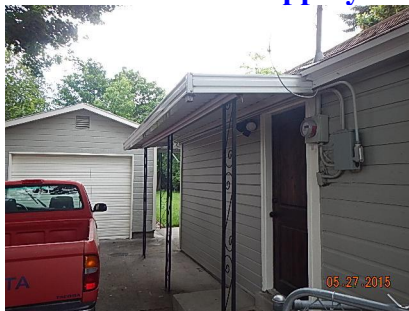
14. Gutters & Downspouts **Repairs Recommended. None Installed. Recommend adding properly installed gutters and downspouts to enhance drainage. Missing downspouts were noted at the time of the inspection. Gutters drain across the concrete which can cause settling, early deterioration and slippery conditions in the winter.**

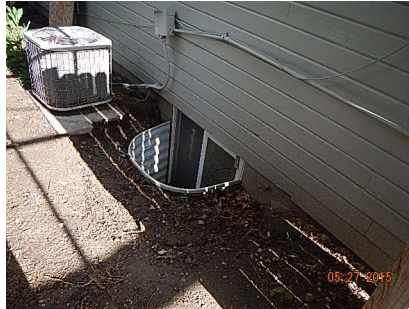
15. Grading **Repairs Recommended. Slope:+Minor. Faulty grade; soil slopes towards structure, which could allow water to enter the basement/crawlspace or cause foundation settling.**

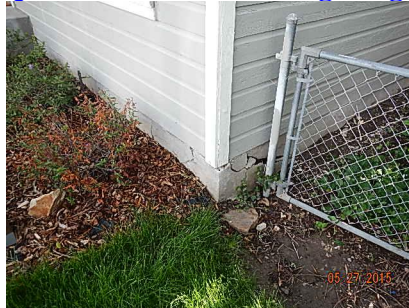
17. Raised **Repairs Recommended. Foundation:+Concrete, Masonry Block: Columns:+Wood. Major cracks and displacement noted. Recommend further evaluation and repairs of foundation by a qualified structural or geological engineer.**

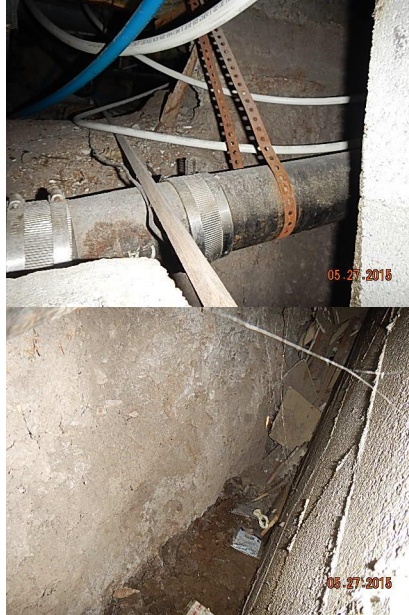
- 17a. Crawlspace **Repairs Recommended. Limited inspection, access wouldn't open. Viewed from basement/rear addition. Exposed footing and poorly contained soils present. Engineer evaluation recommended. Recommend adding properly installed insulation in the crawlspace. Vapor barrier missing and needs to be installed in the crawlspace. Evidence of moisture intrusion present.**

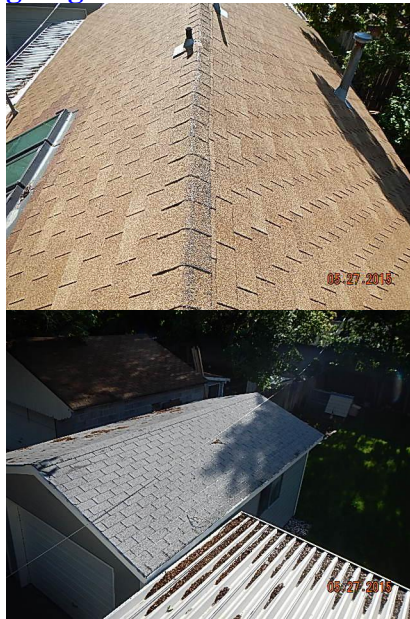
19.	Shingle / Shake	Repairs Recommended. Location:+Main: Roof style:+Gable, Hip: Roof covering is:+asphalt shingles: Roof inspected by:+walking roof: Number of layers:+1. The roof has damaged ridge components. Missing and damaged shingles were noted at time of inspection at the detached garage. Phone wiring is laying on the garage roof.
-----	-----------------	---

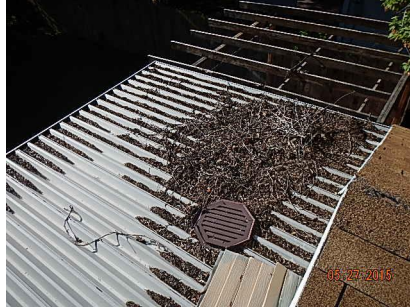
21. Built-up / Low slope

Repairs Recommended. Location:+Patio: Roof style:+Low slope: Roof covering is:+metal panels: Roof inspected by:+walking roof. Recommend clearing roof debris.

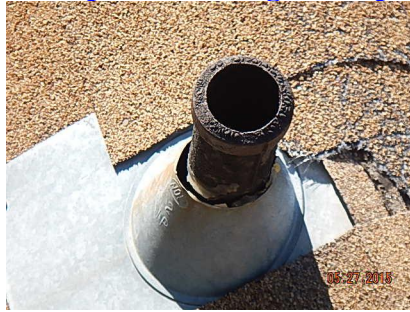
22. Exposed Flashings

Repairs Recommended. Not fully visible *. Separations noted in the exposed flashing at the plumbing vent pipes.

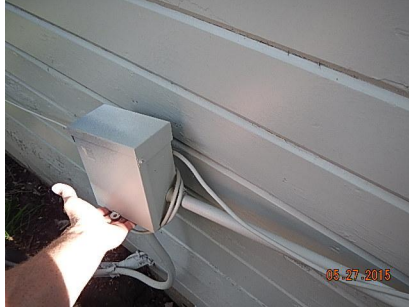
Safety Hazard. Electrical disconnect present: Refrigerant charge (not inspected). Unprotected openings at disconnect. Disconnect is loose. Improper over current protection, manufacture label specifies that the system should not be connected to a breaker larger than 15 amps and the unit is connected to a 30 amp fuse on a 40 amp breaker.

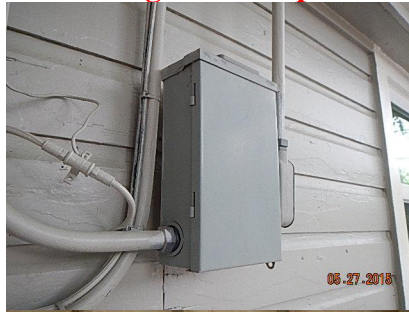
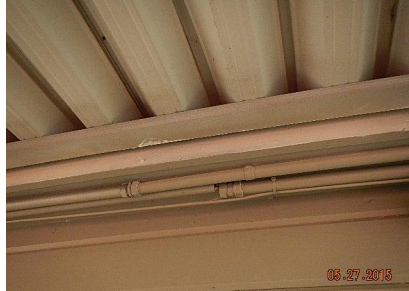
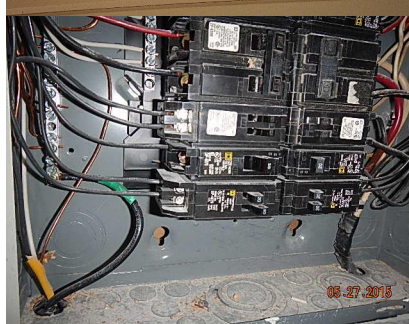
Safety Hazard. Overcurrent protection devices inspected - type:+Breakers. Unprotected openings at: exterior panel. Exterior panel is loose. Damaged conduit noticed at multiple locations. There was a tripped breaker at: Main panel. Check with seller to determine why it was off. Clarify if there are any problems now or in the past with that circuit. Further evaluation may be needed. Seller sad I could try to reset the breaker and it tripped again. The circuits are not labeled properly at: Main panel. Bushings/clamps are missing at: Main panel.

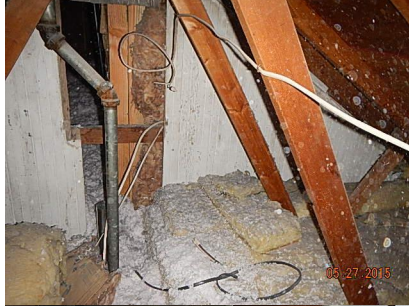
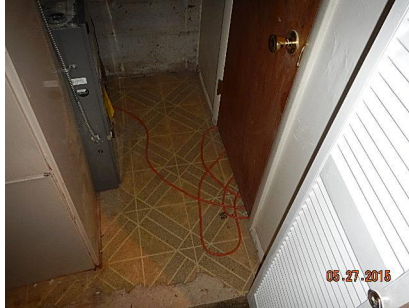
44. Wiring Notes

Safety Hazard. Representative sample of fixtures, switches and outlets appear serviceable.: GFCI(s) responded to test at:+All applicable locations: Furnishings prevent testing of some outlets and switches. *. Exposed wiring needs protection at attic. Extension cord is used as permanent wiring at water heater. Missing outlet/light switch cover plates at laundry room.

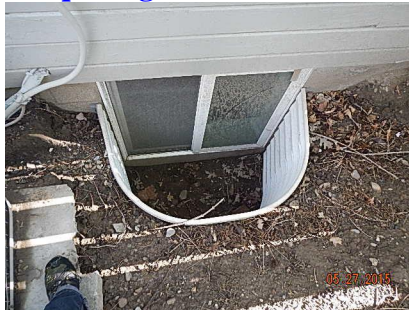
Step #	Component	Comment
45.	Entry Doors	Appears Serviceable.
46.	Interior Doors	Repairs Recommended. Upper bedroom door doesn't close.
47.	Exterior Doors	Repairs Recommended. Rear exterior door was poorly installed, rubs.
48.	Windows	Repairs Recommended. Type:+Dual-pane: Material:+Vinyl. Blinds or shutters are not part of the inspection. Window wells are dirt and debris filled, recommend clearing debris and ensuring adequate gravel is installed for drainage.

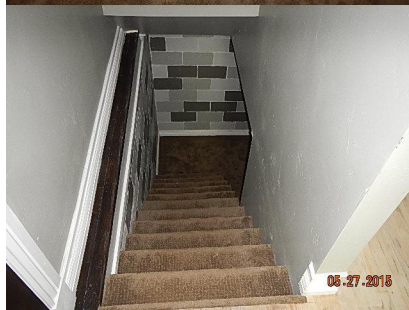
53b.	Interior Stairs	Safety Hazard. Railings are missing. Recommend proper installation for safety. The rise between steps is inconsistent, making the steps difficult to use and unsafe.
------	-----------------	---

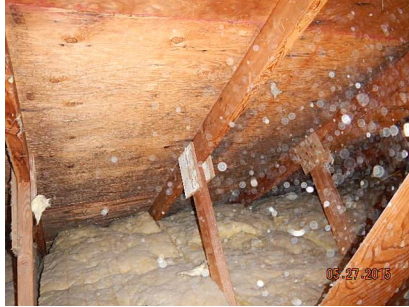
Repairs Recommended. Insulation type:+Fiberglass blown: Vents provided: Ventilation:+appears serviceable: Roof Frame:+Rafter framing: Ceiling Frame:+Rafter framing: Attic:+Full: Access location:+Gable: How Inspected:+Inspection limited to view from access. Mold like growth and moisture damage noticed at multiple locations in the attic. Minimal ventilation in attic. This may not be sufficient to move air through the attic properly.

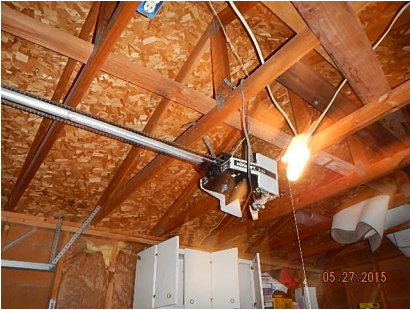
Step #	Component	Comment
57.	Floor	Appears Serviceable.
58.	Firewall/Ceiling	Appears Serviceable.
59.	Ventilation	N/A.
60.	Door to Living Space	N/A. Type:+Fire rated.
61.	Exterior Door	Repairs Recommended. Exterior passage door is damaged and doesn't close.
62.	Vehicle Door	Appears Serviceable. Type:+Roll-up.
63.	Automatic Opener	Repairs Recommended. Number of units:+1: Automatic reverse operated: Electronic sensors present. The automatic opener was disconnected and likely not operational at the time of the inspection. Recommend further evaluation and repairs to automatic openers.

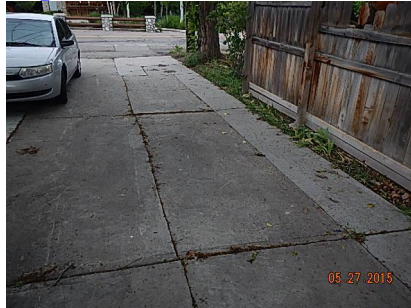
Repairs Recommended. Surface raised or settled, creates trip hazard.

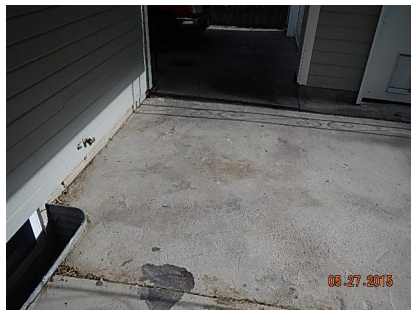
04. Patio

Safety Hazard. Drainage is directed toward the property which may allow water intrusion or foundation settling. The patio surface was raised or settled creating a trip hazard.

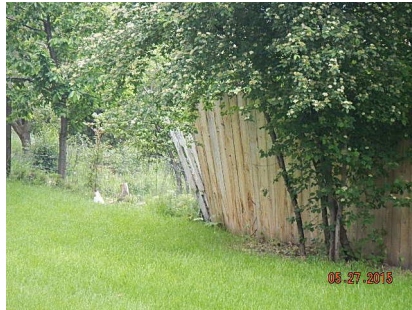
07. Fences & Gates

Repairs Recommended. Damaged fencing present. Gates need adjustment or repair. The fencing had broken/missing boards and posts at the time of the inspection, leaning noticed.

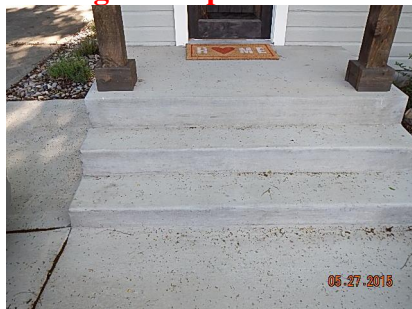
08. Exterior Stairs

Safety Hazard. The rise between steps is inconsistent, making the steps difficult to use and unsafe.

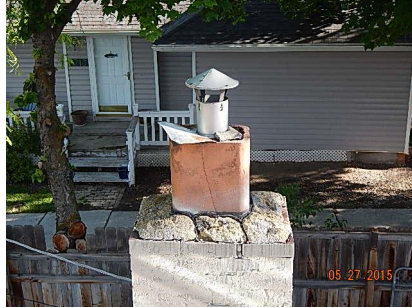
Repairs Recommended. Damaged chimney cap present.

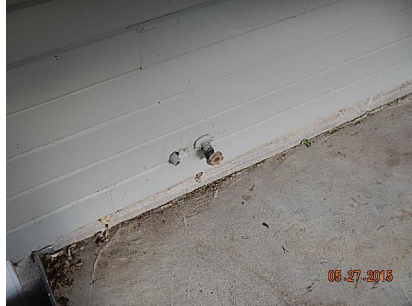
Repairs Recommended. The rear hose faucets were inoperative at the time of inspection.

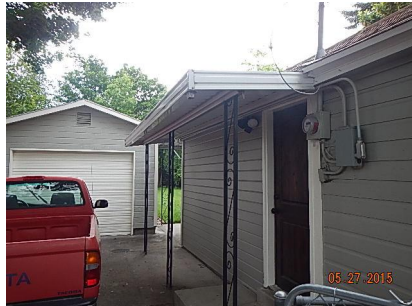
14. Gutters & Downspouts

Repairs Recommended. Recommend adding properly installed gutters and downspouts to enhance drainage. Missing downspouts were noted at the time of the inspection. Gutters drain across the concrete which can cause settling, early deterioration and slippery conditions in the winter.

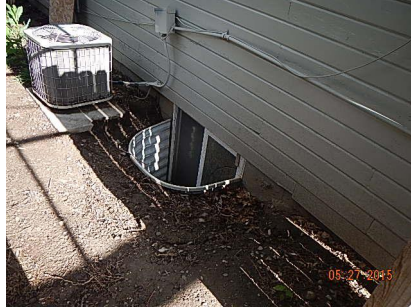
15. Grading

Repairs Recommended. Faulty grade; soil slopes towards structure, which could allow water to enter the

basement/crawlspace or cause foundation settling.

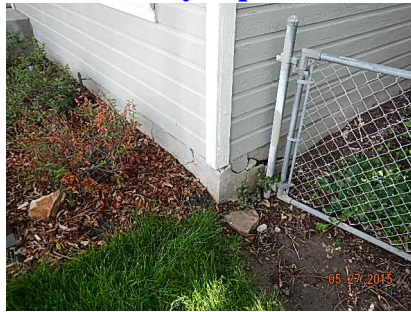
17. Raised Foundation

Repairs Recommended. Major cracks and displacement noted. Recommend further evaluation and repairs of foundation by a qualified structural or geological engineer.

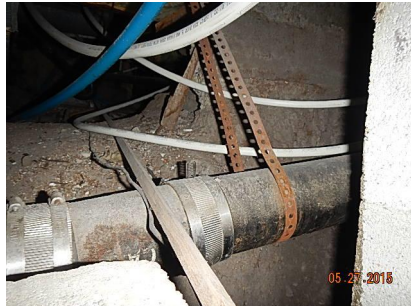
17a. Crawlspace

Repairs Recommended. Limited inspection, access wouldn't open. Viewed from basement/rear addition. Exposed footing and poorly contained soils present. Engineer evaluation recommended. Recommend adding properly installed insulation in the crawlspace. Vapor barrier missing and needs to be installed in the crawlspace. Evidence of moisture intrusion present.

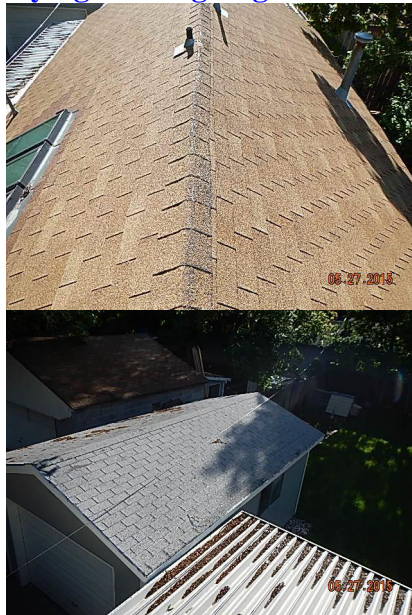
19. Shingle / Shake

Repairs Recommended. The roof has damaged ridge components. Missing and damaged shingles were noted at time of inspection at the detached garage. Phone wiring is laying on the garage roof.

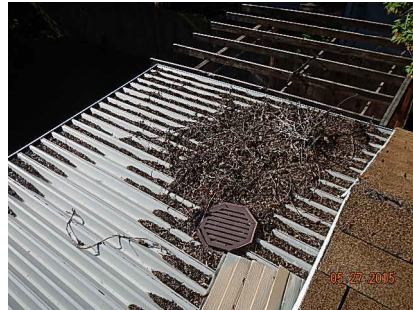
21. Built-up / Low slope

Repairs Recommended. Recommend clearing roof debris.

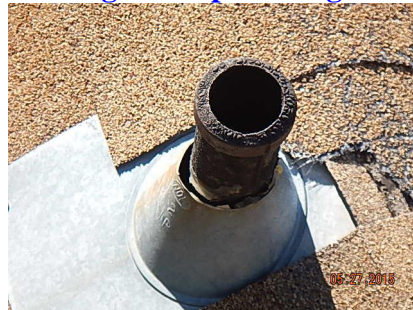
22. Exposed Flashings

Repairs Recommended. Separations noted in the exposed flashing at the plumbing vent pipes.

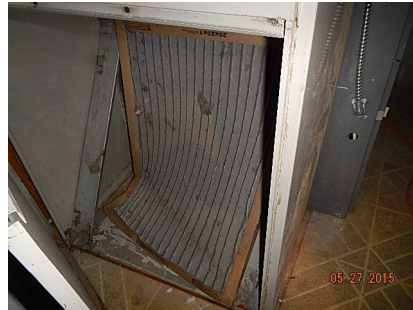
38. Air Conditioning

Repairs Recommended. Unit appears to be 7 years old, typical lifetime is 20-25 years. The air conditioner is not responding to normal controls, not operational.

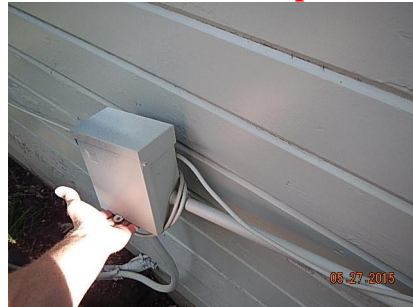
Safety Hazard. Unprotected openings at disconnect. Disconnect is loose. Improper over current protection, manufacture label specifies that the system should not be connected to a breaker larger than 15 amps and the unit is connected to a 30 amp fuse on a 40 amp breaker.

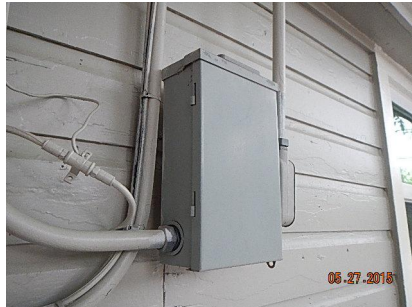
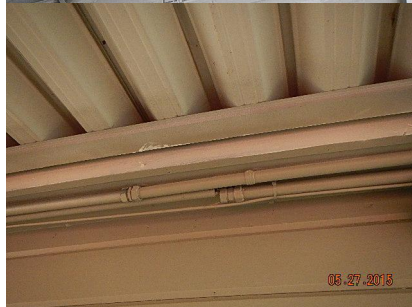
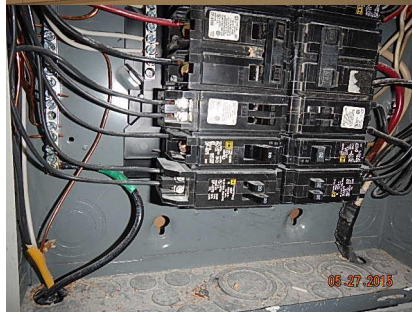
44. Wiring Notes

Safety Hazard. Exposed wiring needs protection at attic. Extension cord is used as permanent wiring at water heater. Missing outlet/light switch cover plates at laundry room.

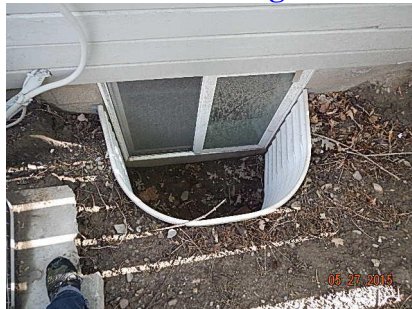
Repairs Recommended. Blinds or shutters are not part of the inspection. Window wells are dirt and debris filled, recommend clearing debris and ensuring adequate gravel is installed for drainage.

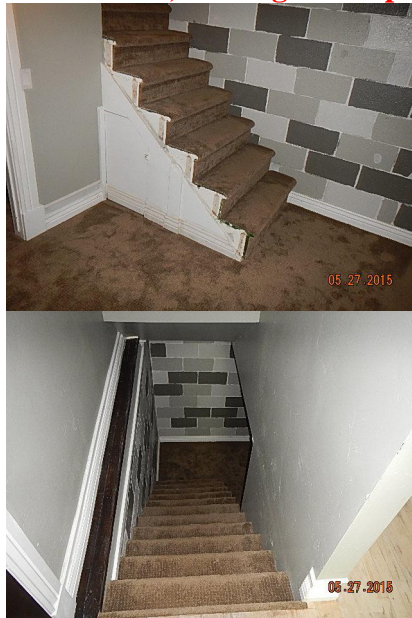
53b. Interior Stairs

Safety Hazard. Railings are missing. Recommend proper installation for safety. The rise between steps is inconsistent, making the steps difficult to use and unsafe.

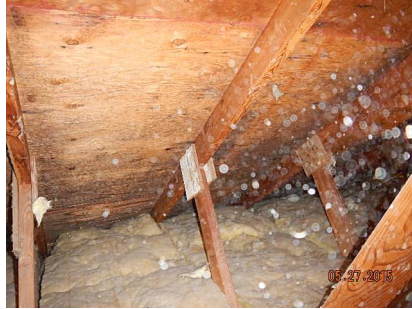
56. Attic General

Repairs Recommended. Mold like growth and moisture

damage noticed at multiple locations in the attic.
Minimal ventilation in attic. This may not be sufficient to
move air through the attic properly.

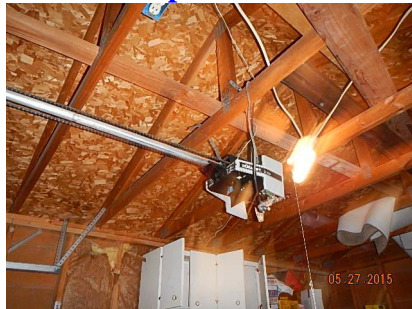
Repairs Recommended. The automatic opener was disconnected and likely not operational at the time of the inspection. Recommend further evaluation and repairs to automatic openers.

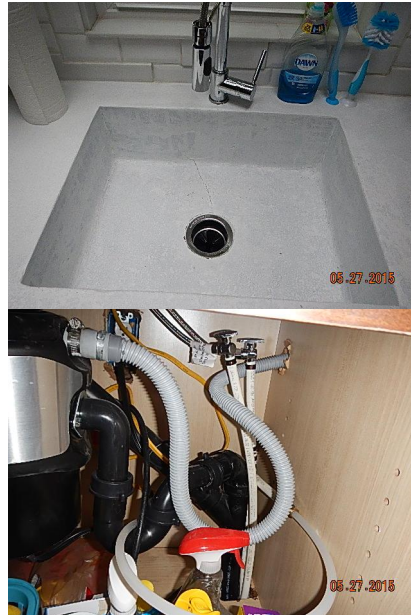
70. Dishwasher

Repairs Recommended. The dishwasher unit was not secured to cabinets. No high loop installed on the dishwasher drain line.
